**3M** ESPE

Making Better Impressions

*Trouble*

*Shooting*  
*Guide*

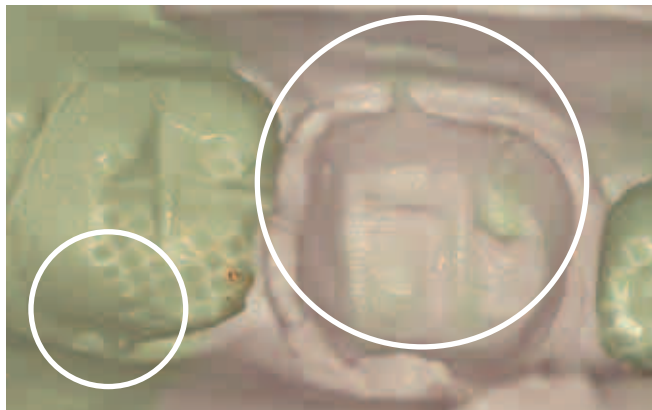
**Visual Appearance:** Voids/holes on margin of the prepared teeth. Incomplete margin.

**Result:** The fit and function of the final restoration may be compromised. Short crown margins and/or open margins.

CAUSE	SOLUTION
Air trapped in intraoral syringe.	Properly bleed filled elastomer syringe.  Keep tip immersed in material when loading syringe.  Do not stop when in the middle of loading syringe.
Air trapped while filling impression tray.	Keep mix tip immersed in tray material while filling the tray.
Improper syringe technique.	Keep syringe tip immersed in wash material to avoid entrapping air.  Wiggle and stir while syringing. Push material forward.
Inadequate coverage of marginal area with light body impression material.	Use wash material liberally on preparation and abutments.

**Void Caused by Syringe Technique**
